GROUP CHAIRMAN'S FACTUAL REPORT OF INVESTIGATION

CEN13FA326 By Bill Tuccio, Ph.D.

Cockpit Voice Recorder

Aircraft: Beechcraft B200GT, N510LD

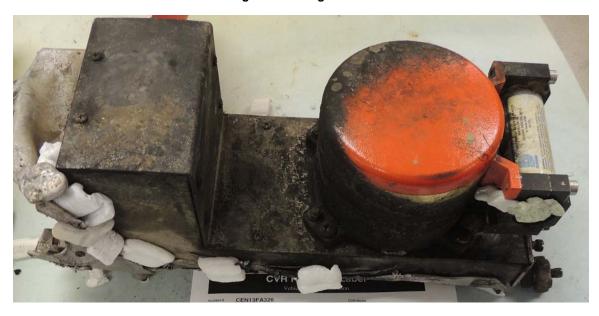
Upon arrival at the audio laboratory, it was evident that the CVR sustained heat and structural damage, as shown in figure 1. The crash protected memory unit was removed, and the internal memory was found intact, as shown in figure 2. The ribbon cable was repaired and the memory installed into an NTSB surrogate L-3 recorder. The recorded contents were downloaded without difficulty.

Figure 1. Damaged CVR.

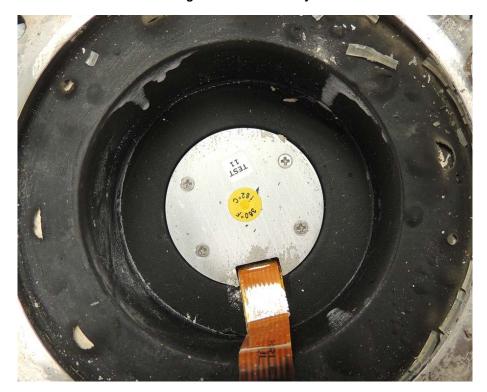
Figure 2. Intact memory.
